Documenting five years of landsliding after the 2005 Kashmir earthquake, using repeat photography

Shah F. Khan^a, Ulrich Kamp^{b,*}, Lewis A. Owen^c

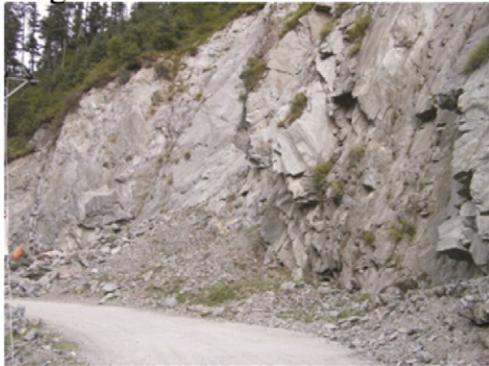
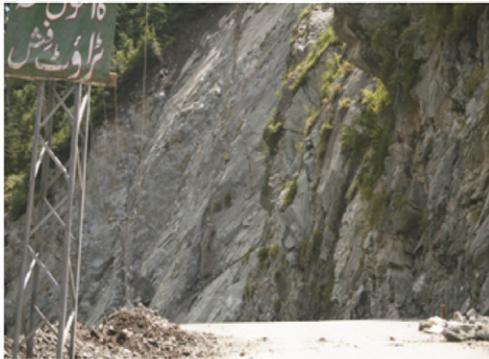
Location #:001 ,Lat/log: N34 39.876 E73 32.067, Altitude:1436m, View Direction:080

Fig. 5. Example of repeated photography using location #001 from 2005, 2007, and 2010 (left) and landslide area (in orange on the right). The landslide area remained almost unchanged over the five years (2005 photograph from inventory by Owen et al., 2008; 2007 photograph from inventory by Khattak et al., 2010; 2010 photograph this study).

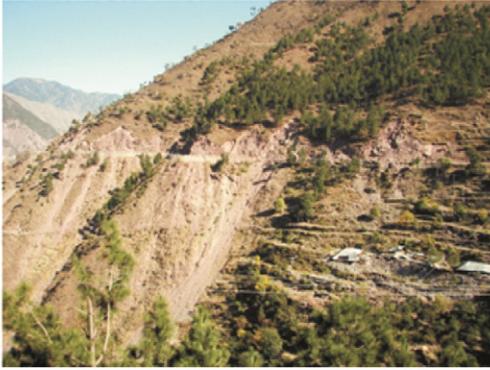
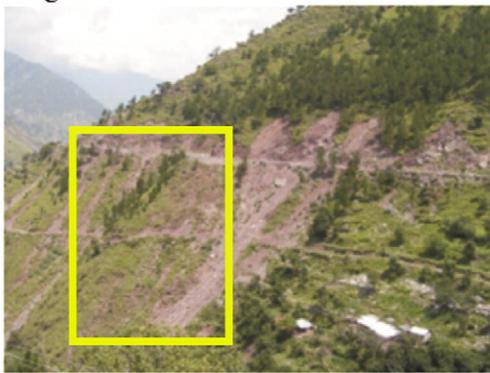
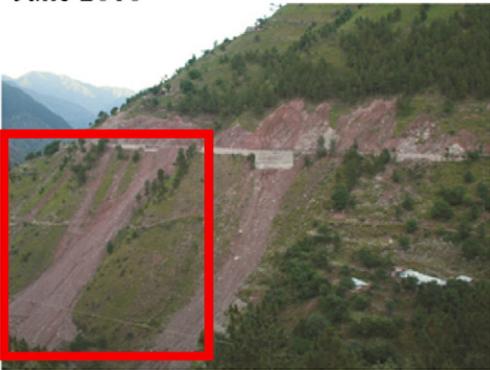
Location #:020, Lat/log: N34 36.678 E73 23.529, Altitude:1409m, View Direction:050°

Fig. 6. Example of repeated photographs using location #020 from 2005, 2007, and 2010 (left) and landslide area (in orange on the right). Although in some smaller parts the vegetation regrew (yellow box), landsliding continued (red box) (2005 photograph from inventory by Owen et al., 2008; 2007 photograph from inventory by Khattak et al., 2010; 2010 photograph this study).

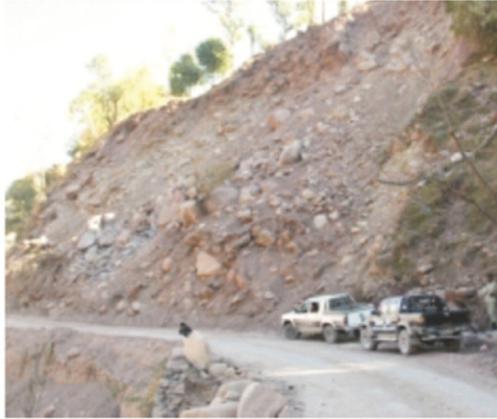
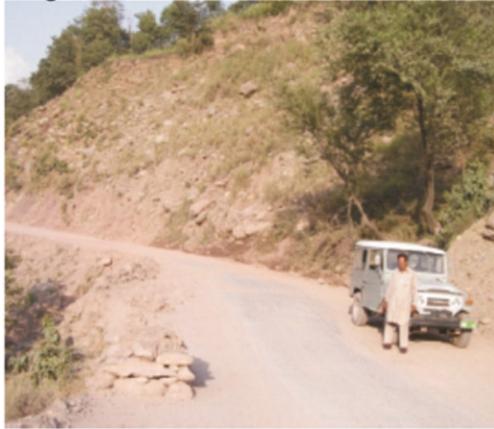
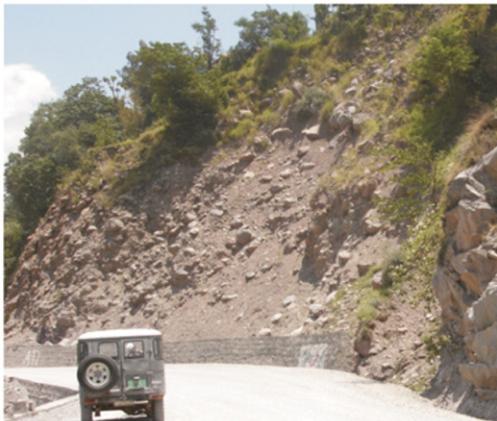
Location #:068, Lat/log: N34 26.386 E73 29.918, Altitude:0793m, View Direction:060°

Fig. 8. Example of repeated photographs using location #068 from 2005, 2007, and 2010 (left) and landslide area (in orange to the right). Although at this road cut vegetation first successfully re-grew and stabilized the slope between 2005 and 2007, new landsliding occurred thereafter by 2010 (2005 photograph from inventory by Owen et al., 2008; 2007 photograph from inventory by Khattak et al., 2010; 2010 photograph this study).

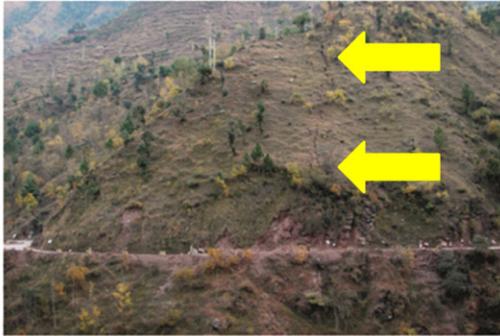
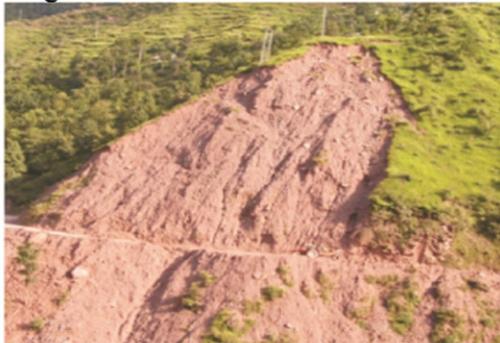
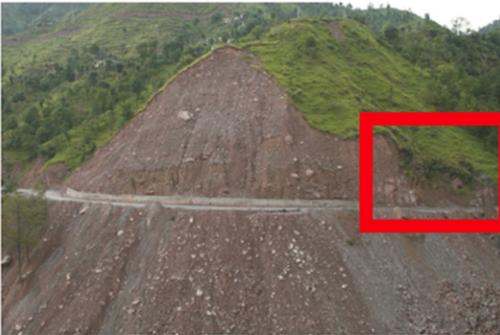
Location #:095, Lat/log: N34 10.817 E73 41.617, Altitude:0980m, View Direction:150°

Fig. 9. Example of repeated photographs using location #095 from 2005, 2007, and 2010 (left) and landslide area (in orange to the right). At this road cut, from 2005 to 2007 fissures (yellow arrows) developed into extensive landsliding; thereafter, the landslide area increased only slightly by 2010 (red box) (2005 photograph from inventory by Owen et al., 2008; 2007 photographs from inventory by Khattak et al., 2010; 2010 photograph this study).
