Neotectonics and Paleoseismology of the Limón and Pedro Miguel Faults in Panamá: Earthquake Hazard to the Panamá Canal

Abstract We present new geologic, tectonic geomorphic, and geochronologic data on the slip rate, timing, and size of past surface ruptures for the right-lateral Limón and Pedro Miguel faults in central Panamá. These faults are part of a system of conjugate faults that accommodate the internal deformation of Panamá resulting from the ongoing collision of Central and South America. There have been at least three surface ruptures on the Limón fault in the past 950–1400 years, with the most recent during the past 365 years. Displacement in this young event is at least 1.2 m (based on trenching) and may be 1.6–2 m (based on small channel offsets). A well-preserved 4.2 m offset suggests that the penultimate event also sustained significant displacement. The Holocene slip rate has averaged about 6 mm/yr, based on a 30-m offset terrace riser incised into a 5-ka abandoned channel.

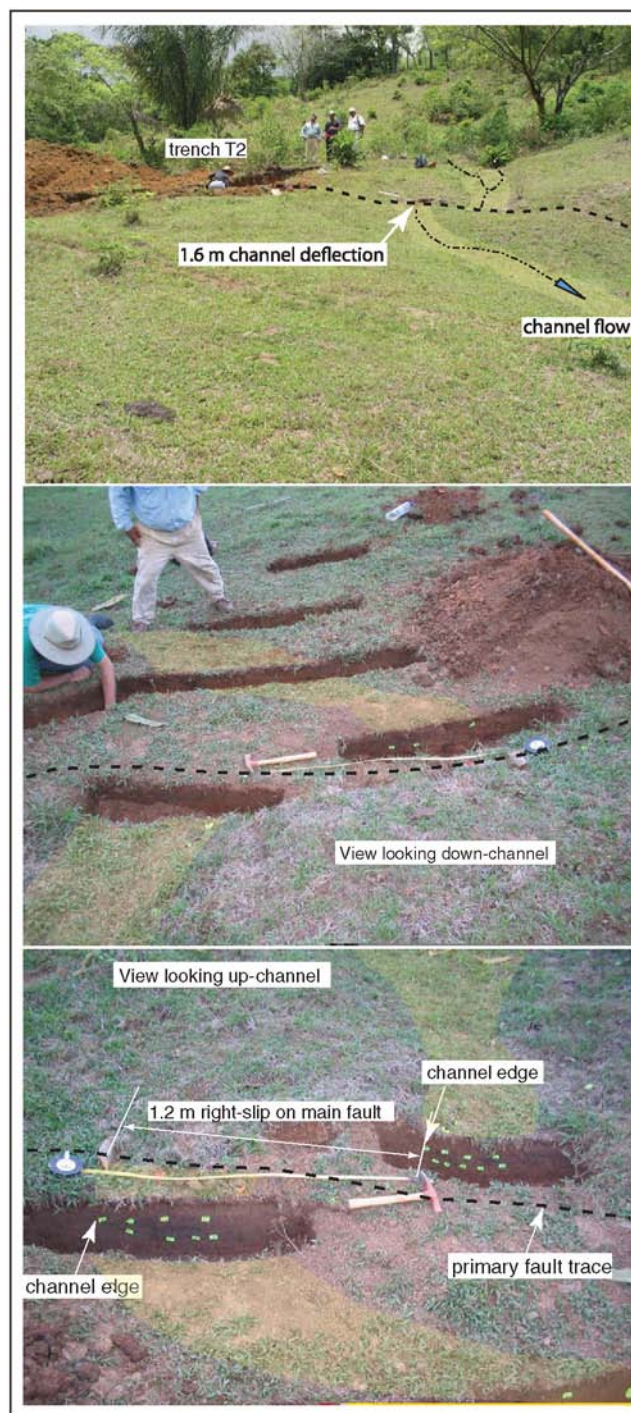
Figure 6. Interpreted photographs of the small, 1.6–2 m offset swale, located a few meters north of trench T2. Several small trenchettes (Fig. 3d) exposed a charcoal-bearing buried channel from which we resolved a minimum of 1.2 m of brittle slip on one of the fault strands. The swale is deflected 1.6 m, with a maximum of about 2 m. The color version of this figure is available only in the electronic edition.

To resolve slip for event W, we hand-excavated five small trenches (trenchettes) in the area of the offset channel, with their axes perpendicular to the channel and parallel to the fault. Two of these trenchettes were most helpful for this study, exposing the edge of the charcoal-bearing channel deposit that is offset by the Limón fault, as discussed in the preceding paragraphs. Using the southwestern edge of the channel as a piercing point, we measured a minimum of 1.2 meters of brittle right-lateral slip for event W on this fault (Fig. 6). Because the trenchettes were excavated to within centimeters of the primary fault trace, the uncertainty for this displacement is small. Observations of this swale prior to trenching suggested the presence of two main fault traces: a western one offsetting the swale approximately 1.6 meters

and an eastern trace offsetting the swale an additional 0.4 m, for a total displacement of about 2 m. The western strand with 1.6 m of apparent deflection corresponds to the minimum of 1.2 m of brittle displacement resolved in

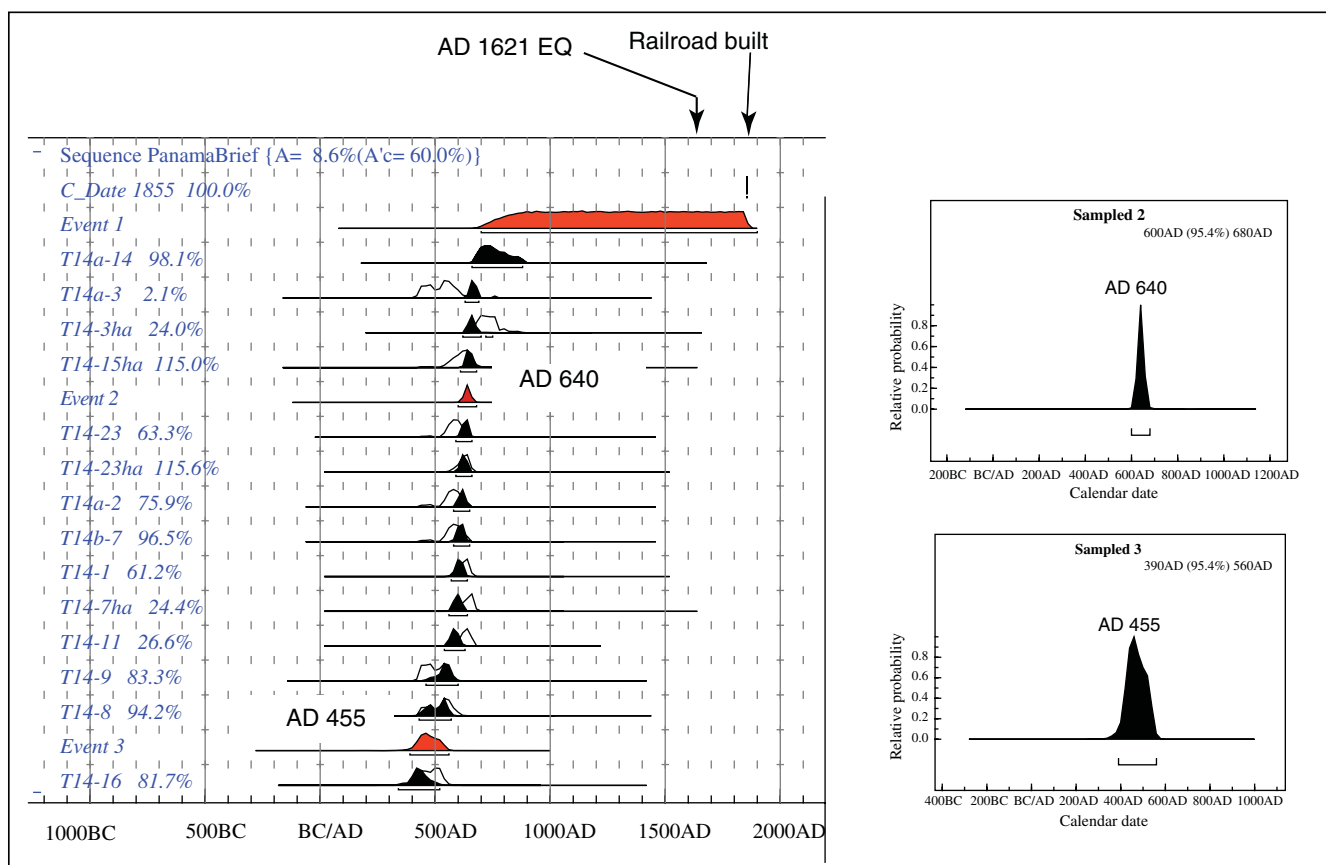
Figure 12. Probability distributions of the youngest radiocarbon dates from each unit. The event ages are plotted individually. Note that deposition at the T14 site apparently ended around 1200 years ago, so the most recent event(s) is poorly constrained in age. Atmospheric data from Reimer *et al.* (2004); OxCal v 3.10, Bronk-Ramsey (2005). The color version of this figure is available only in the electronic edition.

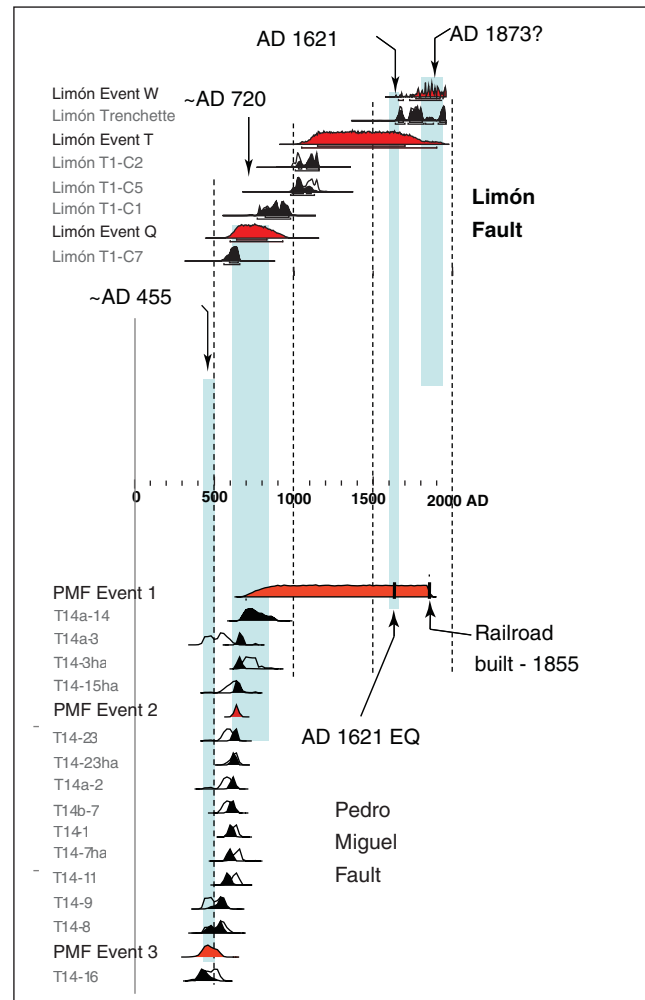
Figure 22. Comparison of dates of surface ruptures from the Limón and Pedro Miguel paleoseismic sites. Note that event Q at the Limón fault has a very similar age to event 2 on the Pedro Miguel fault, suggesting that these two faults may have ruptured together in that event. Also note that the Limón fault sustained two ruptures in the past 1 ka, whereas we only recognize event 1 for the Pedro Miguel fault. Finally, note that event 3 on the Pedro Miguel fault is older than the dated record for the Limón fault, but we speculate that it may correspond to the undated event N at the Limón site. The color version of this figure is available only in the electronic edition.

Figure 22 also plots the probability distributions for the event ages for the Limón and Pedro Miguel faults. The oldest event on the Pedro Miguel fault at approximately AD 455 is older than any of the events recorded for the Limón fault. However, the penultimate Pedro Miguel event and the third Limón fault event have very similar ages at approximately AD 700 and may represent rupture of the entire onshore zone. The MRE for the Pedro Miguel has a large uncertainty in its age when inferred strictly from the radiocarbon dating, but the offset of the Camino de Cruces shows that it is almost certainly the historical earthquake of AD 1621. Similarly, the penultimate Limón event is poorly constrained but overlaps with the penultimate Pedro Miguel event, suggesting that they could have ruptured together. In contrast, the MRE for the Limón fault is certainly younger than the 1621 earthquake and likely represents rupture of only the Limón fault in the late 1800s. Taken together, the data allow the Limón and Pedro Miguel faults to fail together but also indicate that the Limón fault may fail independently from the Pedro Miguel fault, as may have occurred in 1873 or during an aftershock of 1882.
