# GEOMORPHOLOGICAL HAZARDS ALONG THE KARAKORAM HIGHWAY: KHUNJERAB PASS TO THE GILGIT RIVER, NORTHERNMOST PAKISTAN

EDWARD DERBYSHIRE, MONIQUE FORT and LEWIS A. OWEN

*Summary:* The Karakoram Highway traverses one of the most rapidly rising mountain ranges on earth. A combination of earthquakes, glacial erosion, river incision, periglacial action and an unpredictable input of monsoonal rains make it a region of very high geodynamic activity. Since its completion, the Karakoram Highway has been subject to damage and disruption by rockfall, sliding of rock and debris, debris flow, mudflow, dry powder flow, flash flooding by water and torrent gravels, basement undermining by abstraction, subsidence and frost heaving. The road surface is regularly damaged by rockfall impact, floods and frost shattering. Landslides and debris flows have been evaluated using field mapping and gravimetric techniques, and a systematic hazard survey has been completed over a distance of more than 200 km from the Khunjerab Pass (Pakistan – China border) to Gilgit. The largest scale threats are semi-continuous mass movements on oversteepened cliffs of uncemented late-Pleistocene till, and the meltwater streams

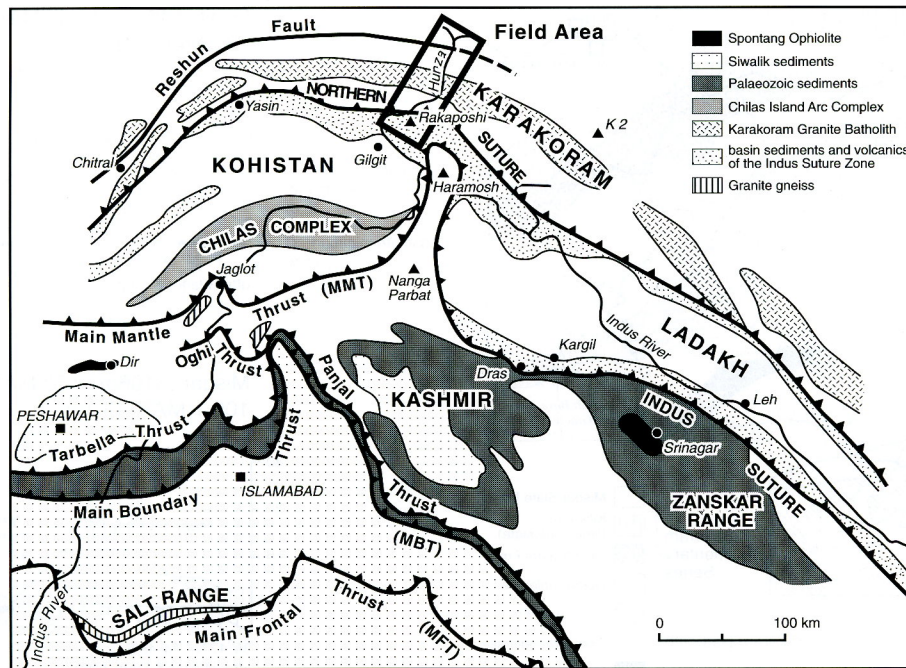
Fig. 2: Outline structural sketch-map of the Karakoram and the western Himalaya of northern Pakistan, showing the surveyed area

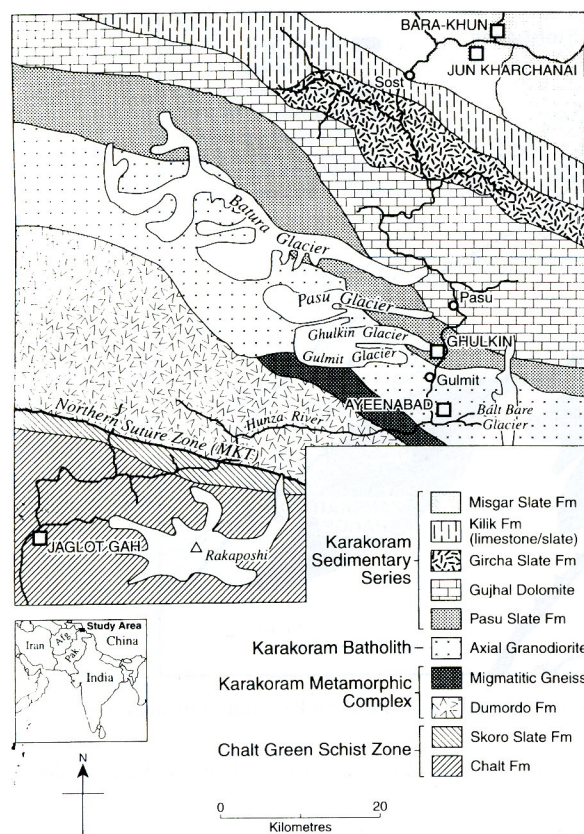
Fig. 3: Generalised geological map of the Karakoram between Rakaposhi and Bara-Khun. Sites of detailed topographical and gravimetric survey are shown by the open box symbols

In the Hunza and Khunjerab valleys, the main structural grain trends WNW-ESE with the major formations mimicking this trend (Fig. 3). For most of its length the KKH, therefore, runs approximately perpendicular to both the structural and lithological trends. The KKH crosses four major geological terrains (SEARLE 1991): the Karakoram Sedimentary Series (in the north), the Karakoram Batholith, the Karakoram Metamorphic Complex; and (in the south) the Chalt Green Schist Zone. The Karakoram Sedimentary Series comprises highly jointed and locally deeply weathered Palaeozoic and Mesozoic slates, limestones and dolomites. Cryogenic weathering dominates in these lithologies to produce steep cliffs that surmount by long scree slopes. The Karakoram Batholith (Tertiary in age) consists mainly of granodiorite but includes diorite and granite. The batholith is deeply incised to form steep cliffs that exhibit impressive cavernous weathering forms. Salt crystal growth and cryogenic processes dominate the weathering throughout this zone. The Karakoram Metamorphic Complex includes gneiss, schist marbles, phyllites, pelite and amphibolites, greenschist, agglomerates and tuffs. These

These structural and lithological characteristics give rise to four main regions along the KKH, each having distinctive geomorphological characteristics. These include (Fig. 3)

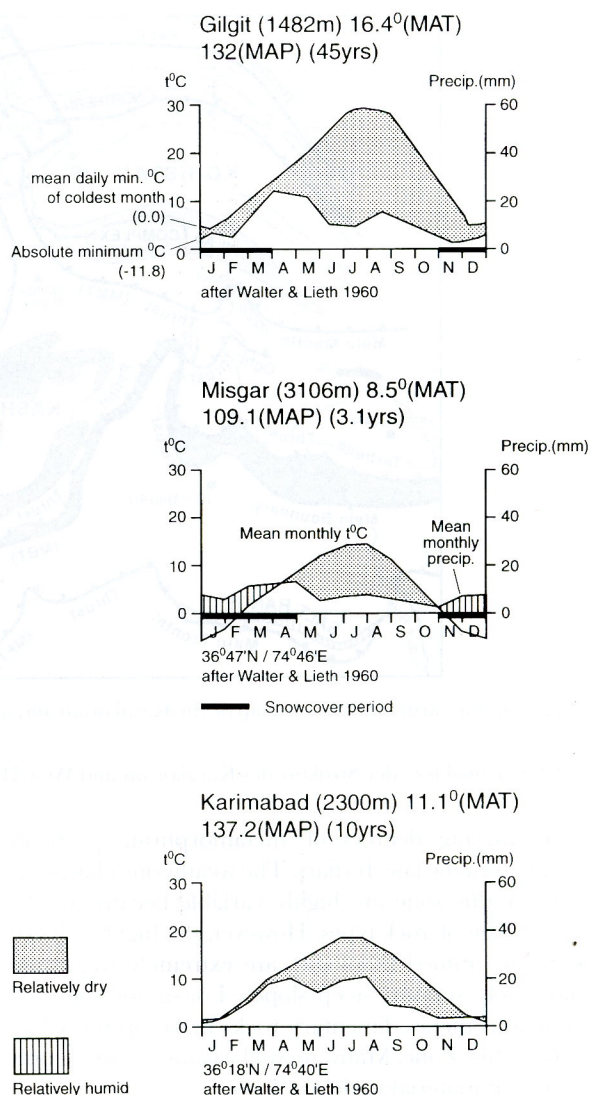
Fig. 4: Graphs of selected climatic data for Gilgit, Karimabad and Misgar

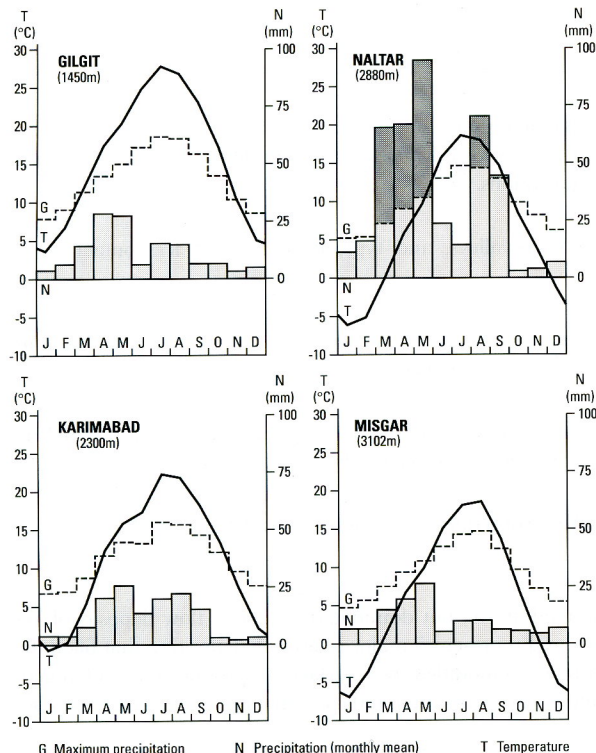
Fig. 5: Climatic means for selected stations in the Hunza valley  
Source: after KREUTZMANN 1989

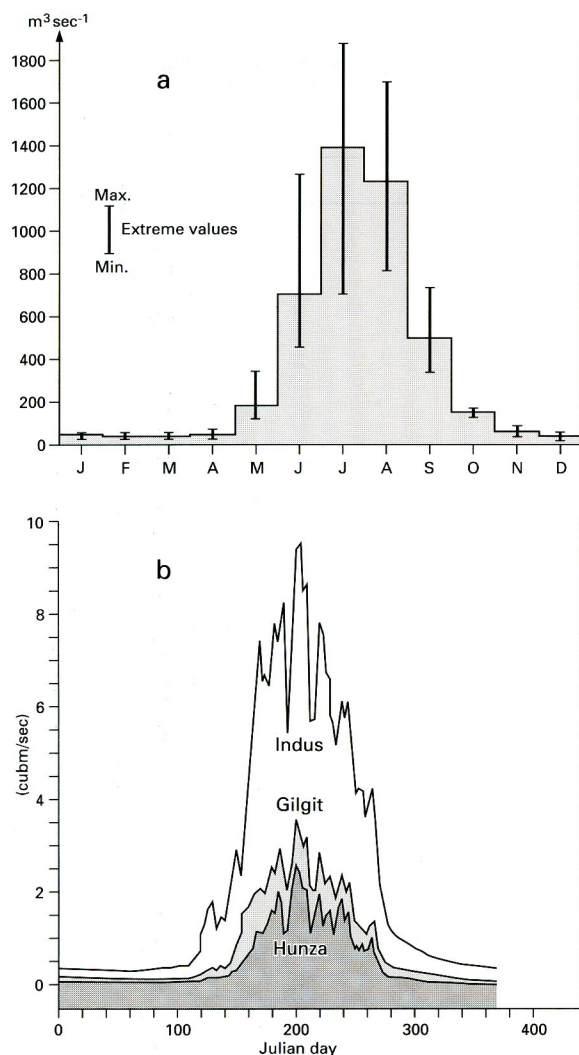
Fig. 6: A: Monthly average and extreme discharge values for Dainyor, 1971–1981

B: Daily runoff means 1973 for the Indus, Gilgit and Hunza rivers

ber (Fig. 6). These meltwater streams feed the main valley rivers that include the Indus, Hunza and Gilgit. Thus, meltwater inputs dominate the discharge and sediment load characteristics of the trunk rivers draining the Karakoram Mountains and the Greater Himalaya.

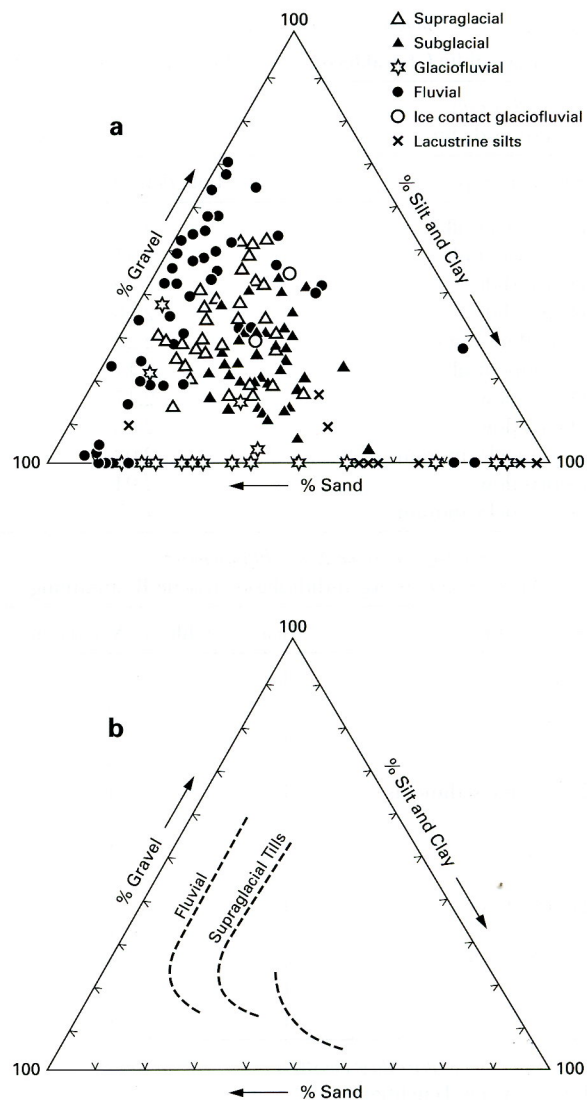
Fig. 7: Ternary diagrams of glacial facies in the Hunza valley  
Source: after LI et al. 1984

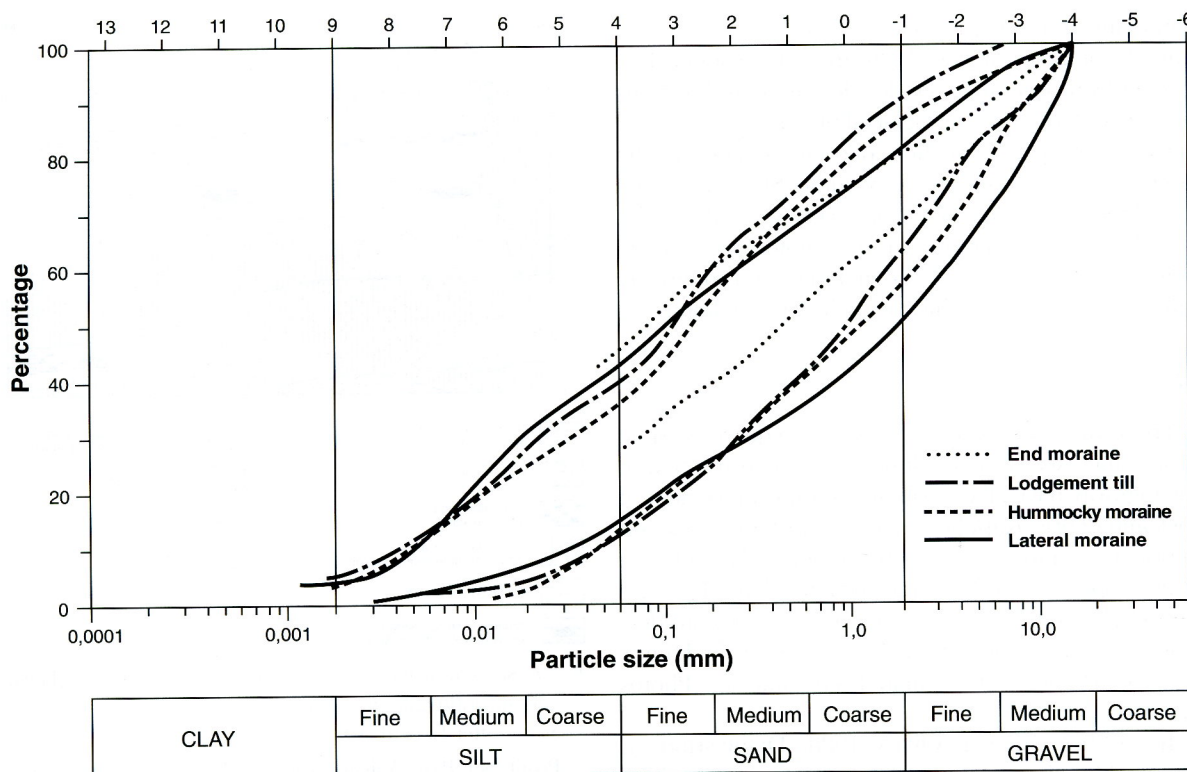
Fig. 8: Particle size envelopes for Hunza valley glaciogenic deposits

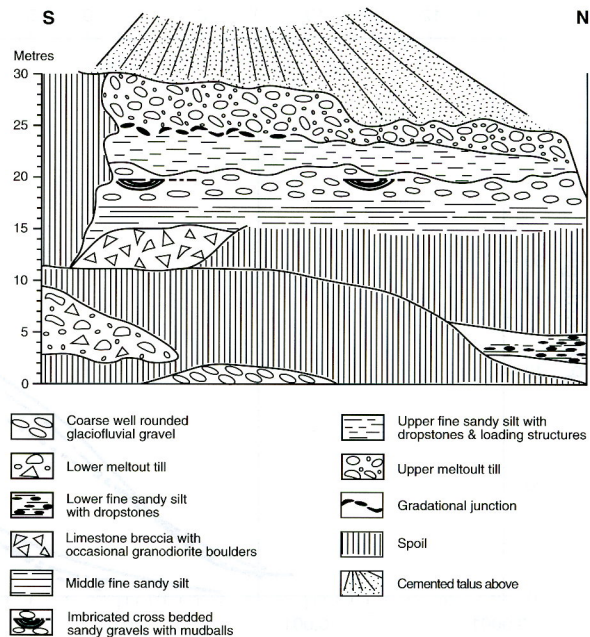
Fig. 9: Section at Pasu village showing complexity of glacial and glaciofluvial intercalation

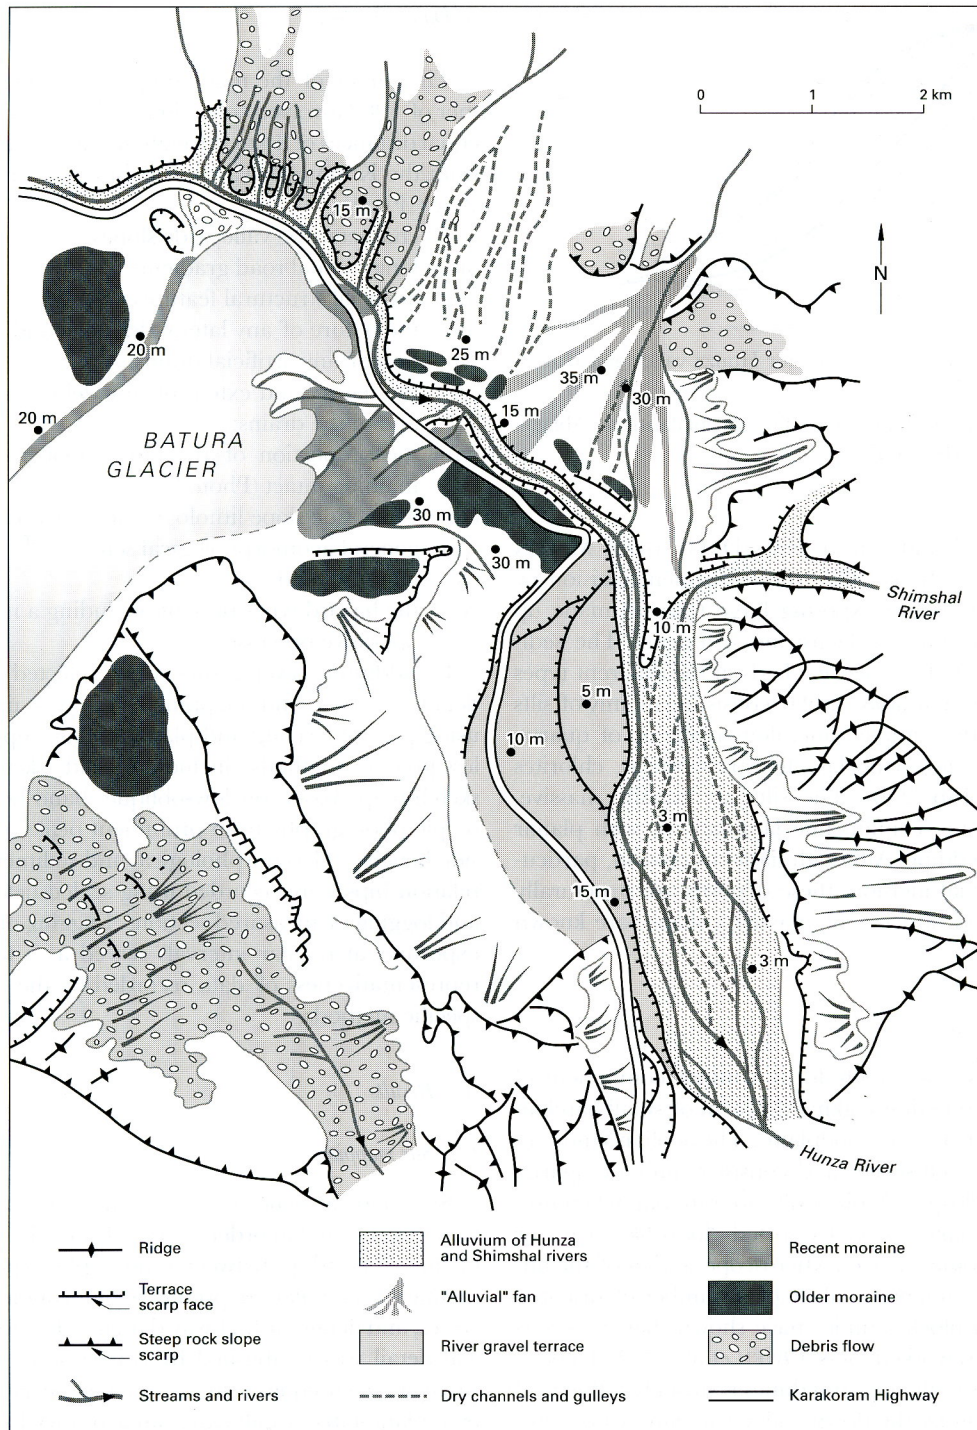
Fig. 10: Map of sedimentary facies near the Batura Glacier terminus, with estimated sediment thicknesses shown for selected sites (in metres)

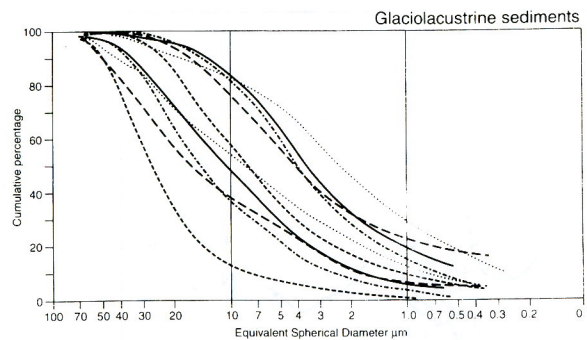
Fig. 11: Particle size envelopes for Hunza valley glaciolacustrine deposits

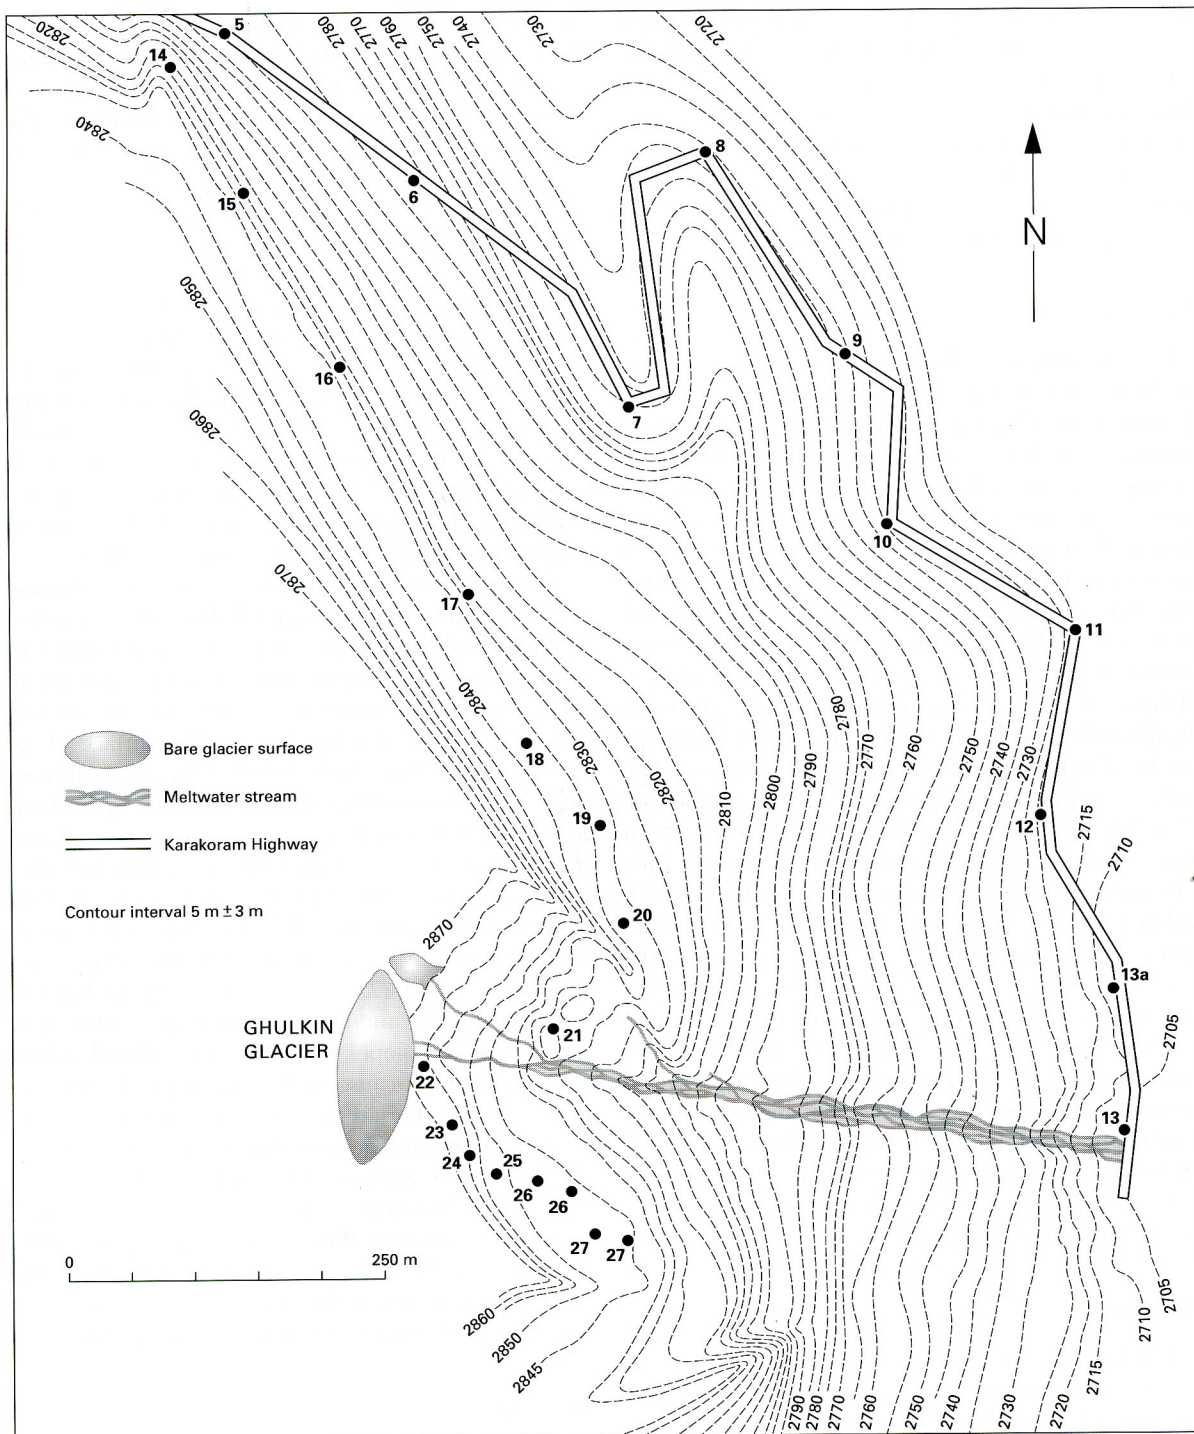
Fig. 12: Site map, with 5 m contour interval, of the central and northern margins of the Ghulkin Glacier  
 Lageskizze vom Mittel- und Nordrand des Ghulikin-Gletschers (mit 5-m-Konturlinien)

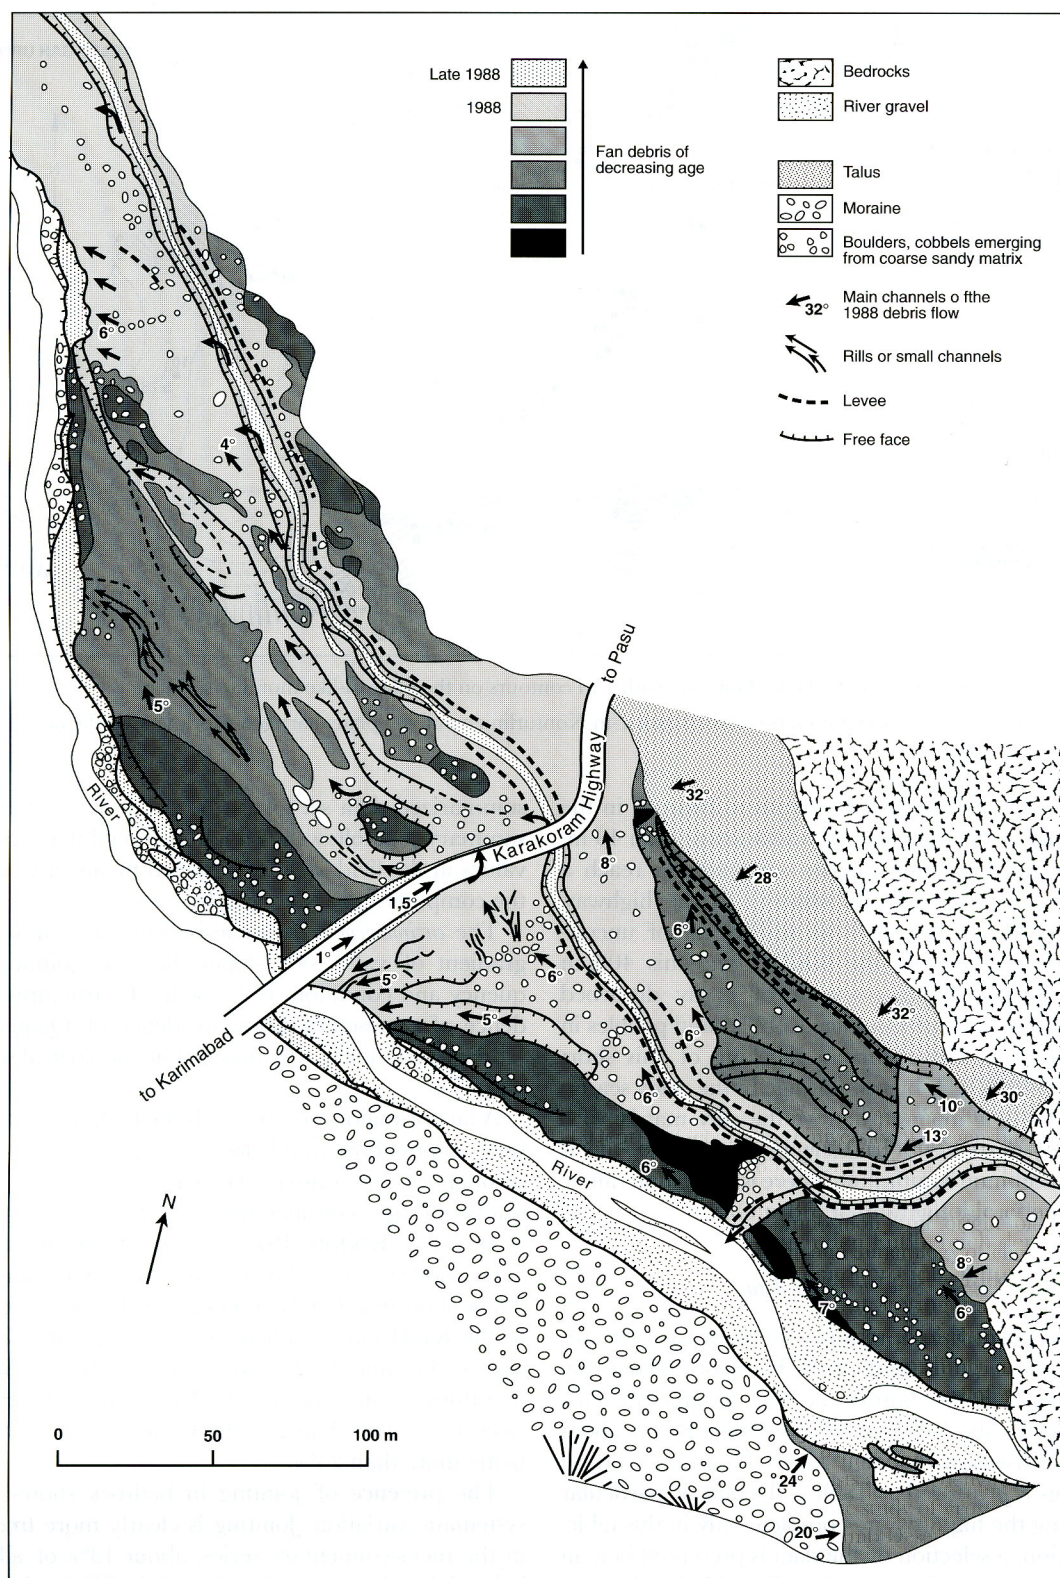
Fig. 13: Sedimentary facies map of the Aycenabad site  
Karte der Sedimentausbildung im Aycenabad-Gebiet

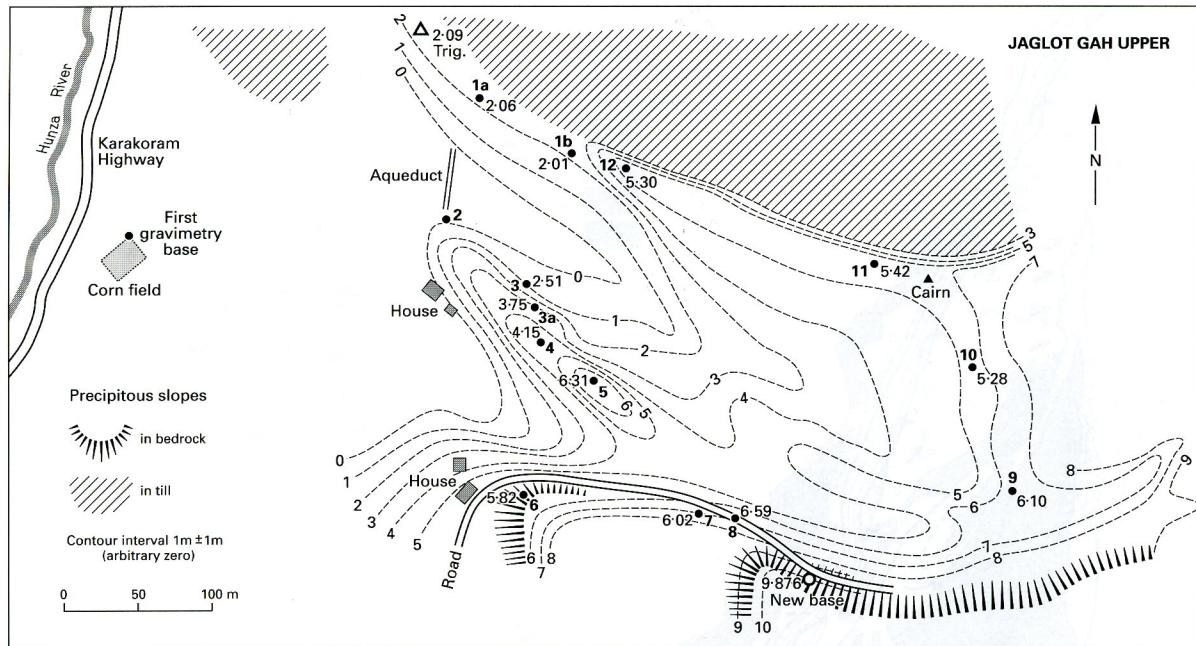
Fig. 14: Site map of the Jaglot Gah site, with 1 m contours on the plateau-like moraine surface

At Jaglot Gah, the KKH follows the left (east) bank of the Hunza River which here cuts transversely across a large compound set of moraine ridges running approximately east-west (Fig. 14). The relative relief on the upper surface of this moraine complex is of the order of 8 m, but incision by the Hunza River has created a steep cliff over 200 m high. The gravimetric

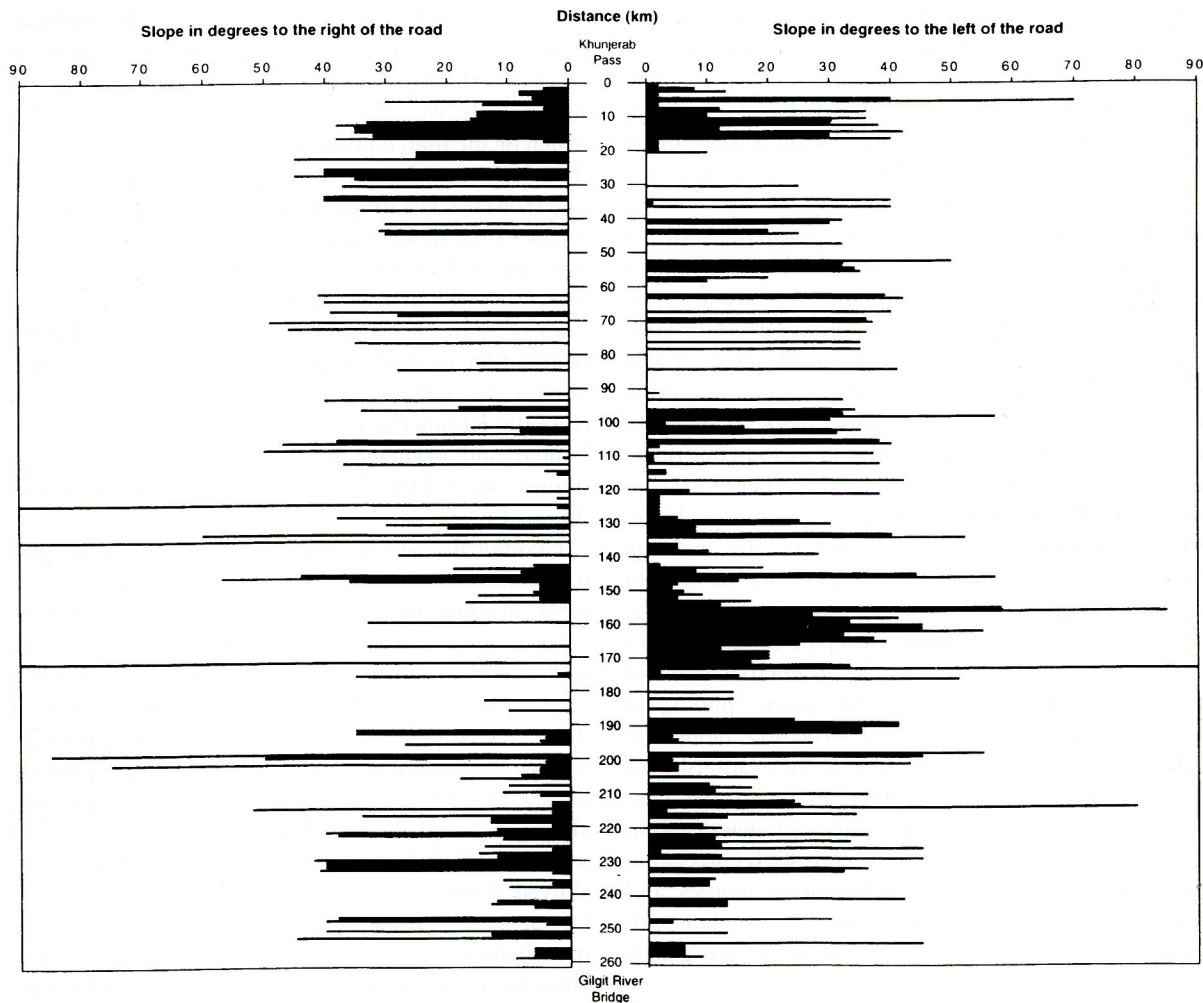
Fig. 15: Slope in degrees to left and right of the KKH from Khunjerab Pass (0 km) to the Gilgit River Bridge (260 km)

The *environment* is characterised by data on average gradient of valley-side slopes (Fig. 15), jointing frequency and condition in the bedrock, structures, incidence of exposed bedrock, incidence of Quaternary sediment cover (Fig. 16), and geomorphological setting (Fig. 17).

A fact of major importance is the high proportion of steep slopes above and below the highway to be found throughout this transect. Data for three of the slope gradient ranges considered geomorphologically critical (CARSON a. KIRKBY 1972), namely those at ca.  $27^\circ$ ,  $>33^\circ$  and  $>40^\circ$ , have been derived from the data-base. These show that 28.6% of all valley side slopes adjacent to the KKH have gradients of  $27^\circ$  or greater, 22.8% exceed  $33^\circ$ , and 13.2% are steeper than  $40^\circ$ . Almost one third of all slopes on the left bank of the Hunza river are steeper than  $27^\circ$ , the value for the right bank being more than  $25^\circ$ .

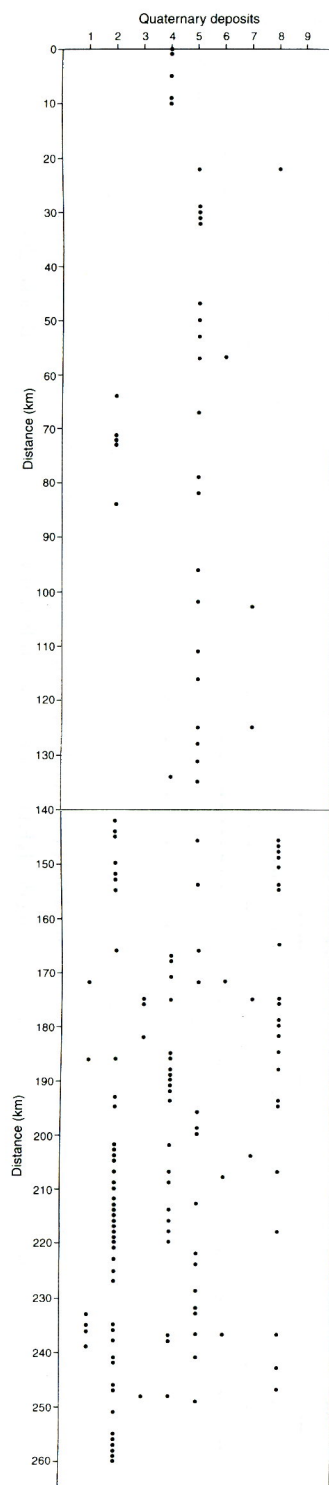
Fig. 16: Incidence of Quaternary deposits along the KKH between Khunjerab Pass (0 km) and the Gilgit River Bridge (260 km)  
Vorkommen von Quartärlagerungen entlang des KKH vom Khunjerab Paß (0 km) bis zur Gilgit River-Brücke

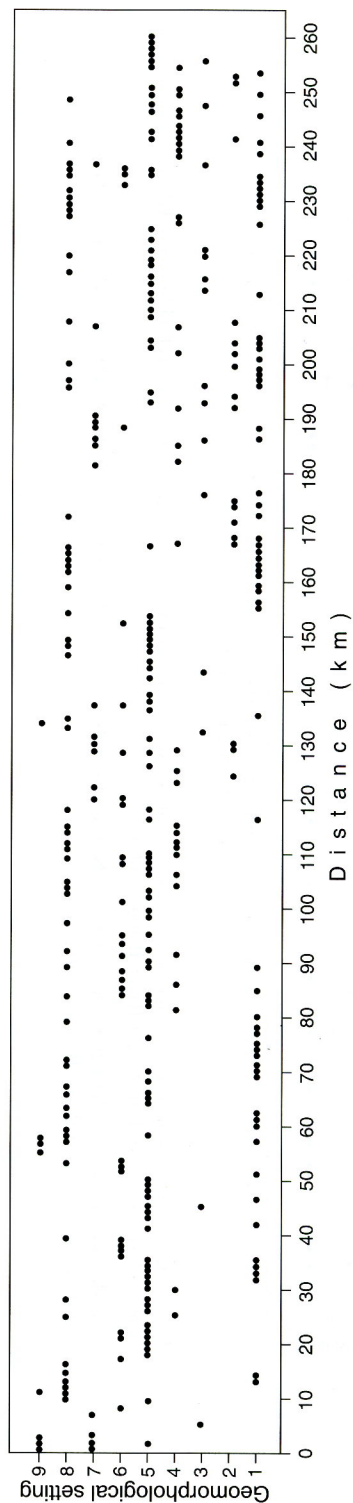
Fig. 17: Geomorphological settings along the KKH between Khunjerab Pass (0 km) to the Gilgit River Bridge (260 km)  
Geomorphologische Umrahmung entlang des KKH vom Khunjerab Paß (0 km) bis zur Gilgit River-Brücke (260 km)

Of the nine geomorphological settings logged at each km post, three are clearly predominant. Gorges and rock cliffs were recorded at almost 25% of all sites, talus/scree slopes occur at more than 24% of sites, while sediment fans (for definition, see DERBYSHIRE *et al.* OWEN 1990) occur at 36% of all sites. Sediment fans are thus the most common geomorphological environment. As is shown later, the high incidence of fan and talus slopes is of great importance in influencing the deterioration of the highway.

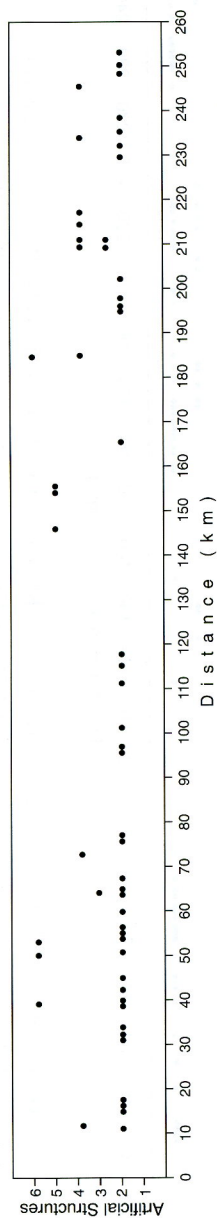
The data on artificial structures (Fig. 18) may be summarised as follows. Culverts occur at more than 20% of sites. Of these, 39.6% were found to be in a state of complete disrepair. Chutes are situated at just less than 10% of sites, but 44% of these were in need of some repair, and 16% had been almost completely destroyed or by-passed by gully erosion and extension, so serving no useful purpose (Photo 10). Embankments designed to protect the highway occurred at more than one quarter (28.4%) of sites, over 16% of these being in need of repair. Retaining walls present a serious problem. Occurring along almost one third of the highway (32.3%), more than 72% were found to be in need of repair, and almost one half of the total number (46.4%) were in a state of complete disrepair in many cases amounting to removal or burial by the encroachment of slope debris. The influence of the geomorphological setting on the various artificial structures along the KKH is probably the single most useful relationship to be drawn from the data-base. Examination of the data-base makes it clear that damage and deterioration along the highway show a consistently high correlation with the three dominant environments (gorges and rock cliffs, talus/scree slopes, and sediment fans), although there are one or two exceptions to this generalisation.

Fig. 18: Incidence of seriously damaged or destroyed artificial structures (grades 4 and higher) along the KKH between Khunjerab Pass (0 km) and the Gilgit River Bridge (260 km)

Certain structures are consistently under-designed on the KKH. For example, the culverts are invariably too small for either the apparent catchment area, the grain size of the adjacent slope debris, or both. Although not always of too small a diameter to transmit peak water discharges, some are clearly smaller than the mean diameter of the boulders in the debris up-slope of them. As a result, they are being plugged and damaged and, in many cases, sediment and water now entirely bypasses them.

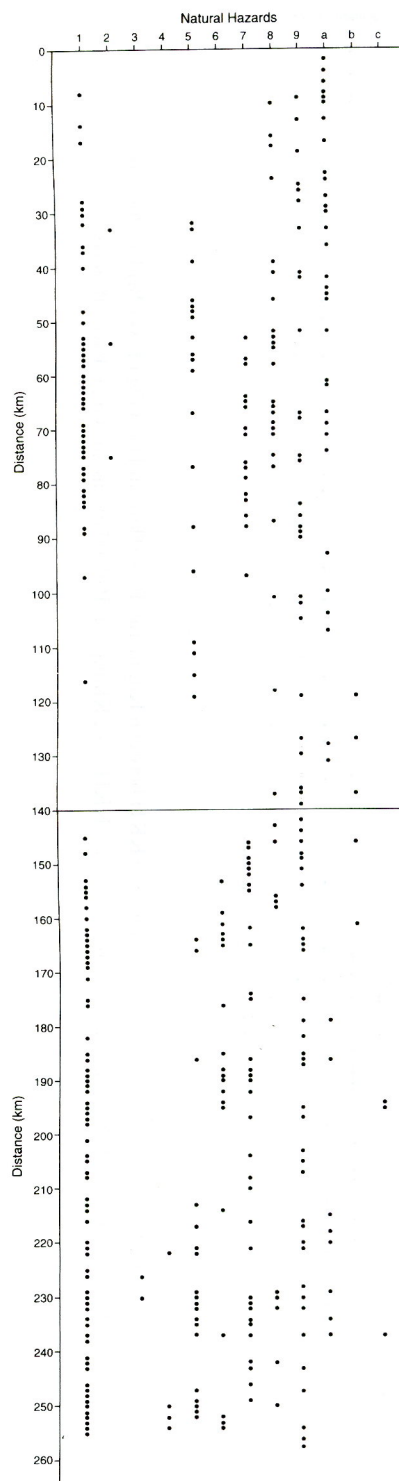
The principal hazards (Fig. 19) include rock and debris slide and fall; flash flooding and fan progradation (including glacial meltwater fans); undermining by fluvial abstraction (especially in the case of the Hunza River, but also on parts of the Khunjerab River); and failure of cliffs of glacial till by saturation of silt matrix giving rise to mass flowage (in the wet season) and aeolian removal of silt matrix and consequent release of boulders (in the dry season). The latter process has received little mention in the literature. The rockfall/debris fall hazard is widespread in the lower valley, but of significance only in the central (gorge sections) of the upper valley. A broadly similar pattern is shown by the mud flow/debris flow hazard, but road failure by subsidence is a much more common hazard in the steeper, upper part of the Hunza valley. The flood hazard is fairly evenly spread down the whole valley. Locations where debris covered glacier ice directly threatens the KKH are relatively few in number. However, the effects at such sites are usually severe (Photo 14).

Fig. 19: Types of natural hazard along the KKH between Khunjerab Pass (0 km) and the Gilgit River Bridge (260 km)  
Typen naturräumlicher Hazards entlang des KKH vom Khunjerab Paß (0 km) bis zur Gilgit River-Brücke (260 km)
